MICROCHIP PIC16C63A/65B/73B/74B

PIC16C63A/65B/73B/74B Rev. A Silicon/Data Sheet Errata

The PIC16C63A/65B/73B/74B parts you have received conform functionally to the Device Data Sheet (DS30605C), except for the anomalies described below.

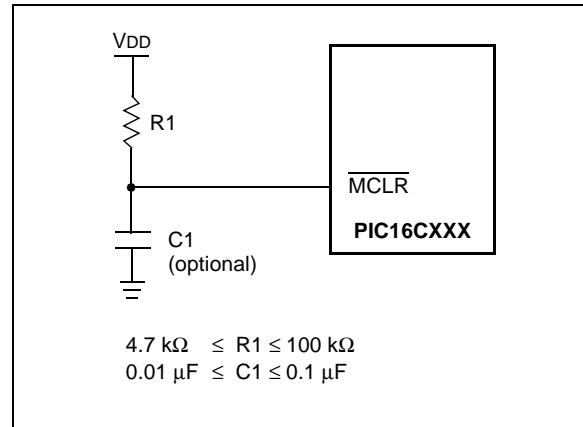
FIGURE 1: $\overline{\text{MCLR}}$ EXTERNAL CIRCUIT

The minimum specification for the $\overline{\text{MCLR}}$ must be met in order to reset the PIC16CXXX. If a $\overline{\text{MCLR}}$ pulse occurs that is less than the minimum specification (parameter #30), improper device operation can occur.

If the minimum specification cannot be met, then an external circuit must be used to ensure that any pulse width less than the specification will be filtered before it reaches the $\overline{\text{MCLR}}$ pin.

A possible circuit is shown in Figure 1. This circuit works by delaying the $\overline{\text{MCLR}}$ release following a power-up. If no delay is required, the capacitor may be omitted.

An alternative would be to use a supervisory circuit to control $\overline{\text{MCLR}}$.

Design validation should be performed to verify that the application works as expected.

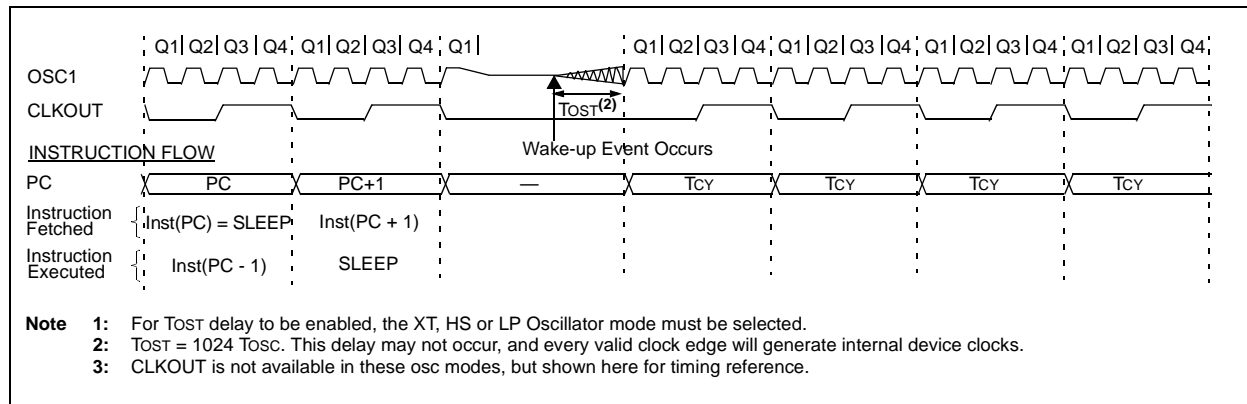
FIGURE 2: WAKE-UP FROM SLEEP

The Oscillator Start-up Timer (TOST) delay may not occur when the device wakes up from SLEEP.

Figure 2 shows the start-up of the crystal after the event that causes the device to wake-up from SLEEP mode (as specified in device data sheet). The start-up time (TOST) may not occur.

In applications where time-based measurements are started immediately after wake-up from SLEEP, the suggested work around should be implemented.

After the SLEEP instruction, do a software delay of 256 T_{CY} (same as 1024 T_{OSC}). At the RESET and Interrupt vector addresses, test to see if the device woke from SLEEP (the \overline{TO} and \overline{PD} bits), and if the device did wake from SLEEP, ensure that the total cycle delay is 256 T_{CY}.

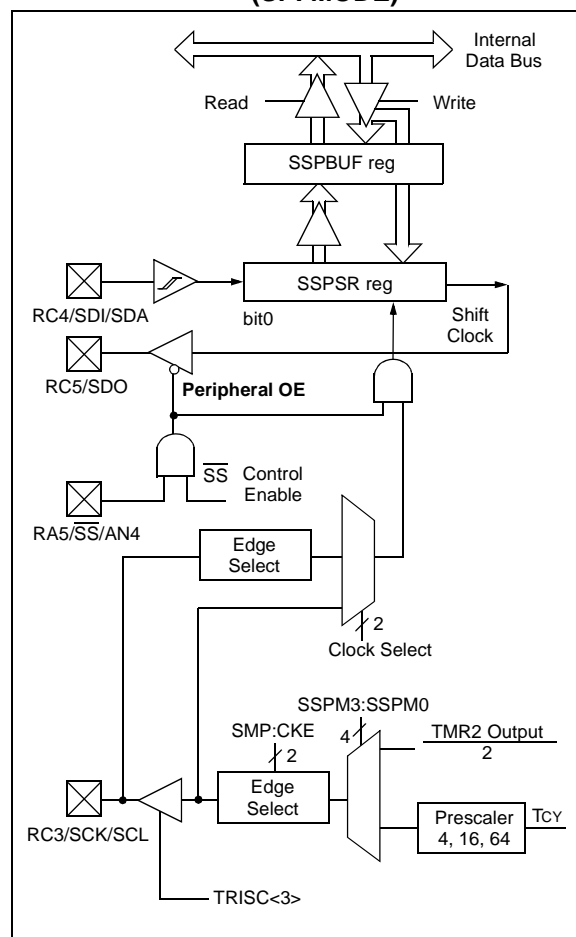
FIGURE 10-1: SSP BLOCK DIAGRAM (SPI MODE)

In Section 10.2 ("SPI Mode"), Figure 10-1 and the note box immediately beneath it have been amended to better demonstrate the Peripheral OE line of the SSP module and describe its relationship to the TRISC<5> bit of PORTC.

3: When the SPI is in Slave mode with \overline{SS} pin control enabled ($SSPCON<3:0> = 0100$), the state of the \overline{SS} pin can affect the state read back from the TRISC<5> bit. The Peripheral OE signal from the SSP module into PORTC, controls the state that is read back from the TRISC<5> bit (see Section 5.3 for information on PORTC). If Read-Modify-Write instructions, such as **BSF**, are performed on the TRISC register while the \overline{SS} pin is high, this will cause the TRISC<5> bit to be set, thus disabling the SDO output.
