PIC16F818/819 Rev. A4 Silicon Errata Sheet

The PIC16F818/819 Rev. A4 parts you have received conform functionally to the Device Data Sheet (DS39598E), except for the anomalies described below.

The following silicon errata apply only to PIC16F818/819 devices with these Device/Revision IDs:

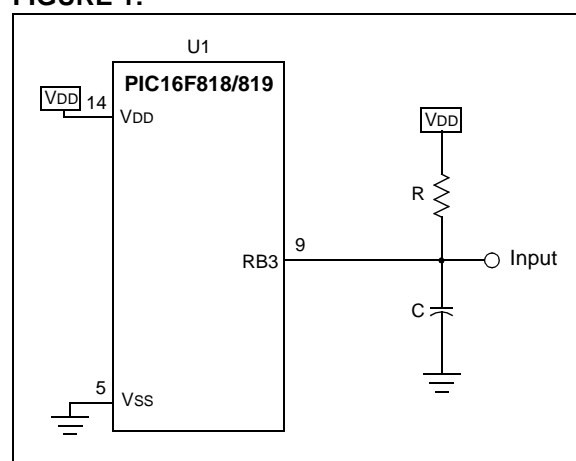
FIGURE 1:

If the following conditions are present on RB3, a device Reset may occur.

1. RC combination on RB3 (see Figure 1).
2. RB3 configured as an input via TRISB.
3. RB3 is driven low.

1. A Reset condition may not occur if a specific resistor/capacitor combination is used. It has been observed that a 10 kΩ resistor and a capacitor value of 4.7 nF or less does not cause a device Reset. If the user must have a RC configuration using RB3, then experimenting with different RC values is recommended.
2. Do not configure RB3 with the above conditions shown in Figure 1. Instead, use another I/O pin for the RC configuration.
