**MICROCHIP****PIC18F2525/2620/4525/4620****PIC18F2525/2620/4525/4620 Rev. A4 Silicon Errata**

**The following silicon errata apply only to PIC18F2525/2620/4525/4620 devices with these Device/Revision IDs:**

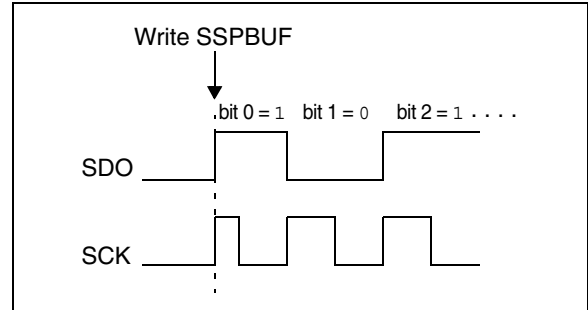
**FIGURE 1: SCK PULSE VARIATION USING TIMER2/2**

When the SPI is using Timer2/2 as the clock source, a shorter than expected SCK pulse may occur on the first bit of the transmitted/received data (Figure 1).

To avoid producing the short pulse, turn off Timer2 and clear the TMR2 register, load the SSPBUF with the data to transmit and then turn Timer2 back on. Refer to Example 5 for sample code.
