**MICROCHIP****PIC18F2515/2610/4515/4610****PIC18F2515/2610/4515/4610 Rev. A4 Silicon Errata**

The PIC18F2515/2610/4515/4610 Rev. A4 parts you have received conform functionally to the Device Data Sheet (DS39636C), except for the anomalies described below. Any Data Sheet Clarification issues related to the PIC18F2515/2610/4515/4610 will be reported in a separate Data Sheet errata. Please check the Microchip web site for any existing issues.

**The following silicon errata apply only to PIC18F2515/2610/4515/4610 devices with these Device/Revision IDs:**

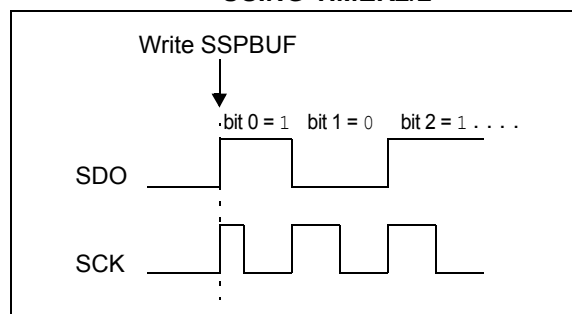
**FIGURE 1: SCK PULSE VARIATION USING TIMER2/2**

When the SPI is using Timer2/2 as the clock source, a shorter than expected SCK pulse may occur on the first bit of the transmitted/received data (Figure 1).

To avoid producing the short pulse, turn off Timer2 and clear the TMR2 register, load the SSPBUF with the data to transmit and then turn Timer2 back on. Refer to Example 5 for sample code.
