Operational Issues

MPLAB® ICD 2 Design Advisory

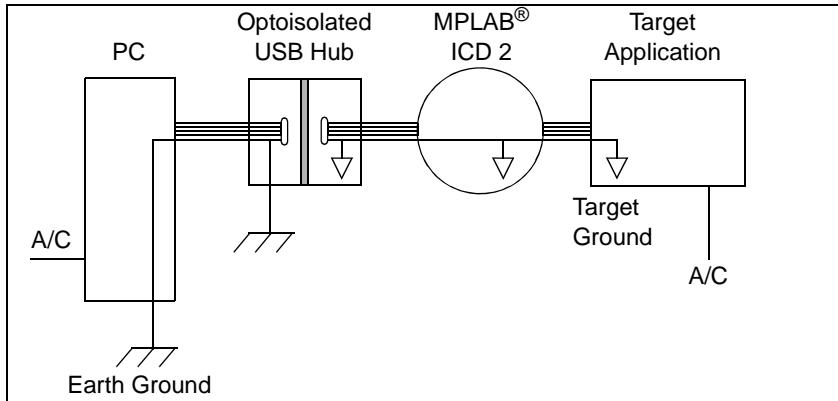
FIGURE 1-1: EXAMPLE MPLAB® ICD 2 SETUP FOR NON-ISOLATED AC POWER SYSTEMS

The MPLAB ICD 2 must be isolated from an application target utilizing AC line power with no isolation. Carefully consider the ground and signal return connections and their differing voltage potentials before connecting the MPLAB ICD 2 to the target.

The MPLAB ICD 2 connects to earth ground from the USB connector interface through the PC and from the external brick power supply connector. For non-isolated AC line power applications, system interfaces must float and not be referenced to ground to prevent damaging the MPLAB ICD 2 once it's connected to the target. This means the MPLAB ICD 2 must be referenced to the same ground potential as the target.

Using the MPLAB ICD 2 without ensuring ground isolation will result in damage to the MPLAB ICD 2 or the target system as the full AC mains voltage will be applied.

For these applications, an optoisolated hub should be used between the PC and the MPLAB ICD 2 to provide isolation from the PC's earth ground through the USB cable. Do not use the MPLAB ICD 2 external power supply. This configuration is shown in Figure 1-1.

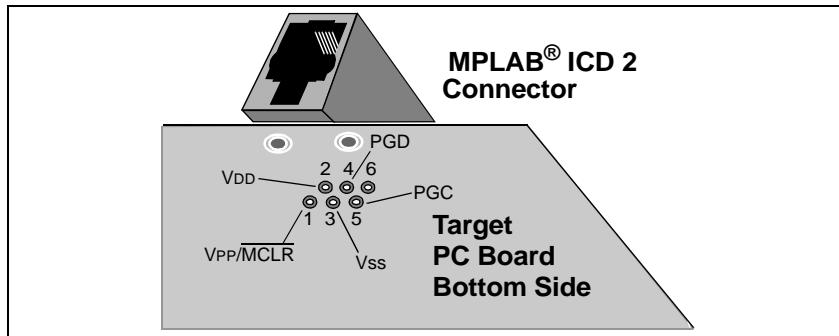
FIGURE 1-2:

In some cases, depending on the revision of the MPLAB ICD 2 and the dsPIC30 DSC device, a crosstalk problem may exist when the device is being programmed. Due to the locations of the PGC and PGD pins, crosstalk may degrade the signal and cause the MPLAB ICD 2 to fail programming of the target device. To correct this, try the following:

1. Construct a RJ12 modular cable and replace the 15-inch cable that comes with the MPLAB ICD 2. Keep the length as short as possible, preferably under 6 inches. Also, remove the jacket from the cable, so that the conductors are far apart from each other (especially the PGC and PGD signals). The standard MPLAB ICD 2 modular cable is wired as shown in Figure 1-2, that is, RJ12 pin 1 on one end connects to RJ12 pin 6 on the other end. This solves the problem in nearly all cases.
