# PIC18F2420/2520/4420/4520

## PIC18F2420/2520/4420/4520 Data Sheet Errata

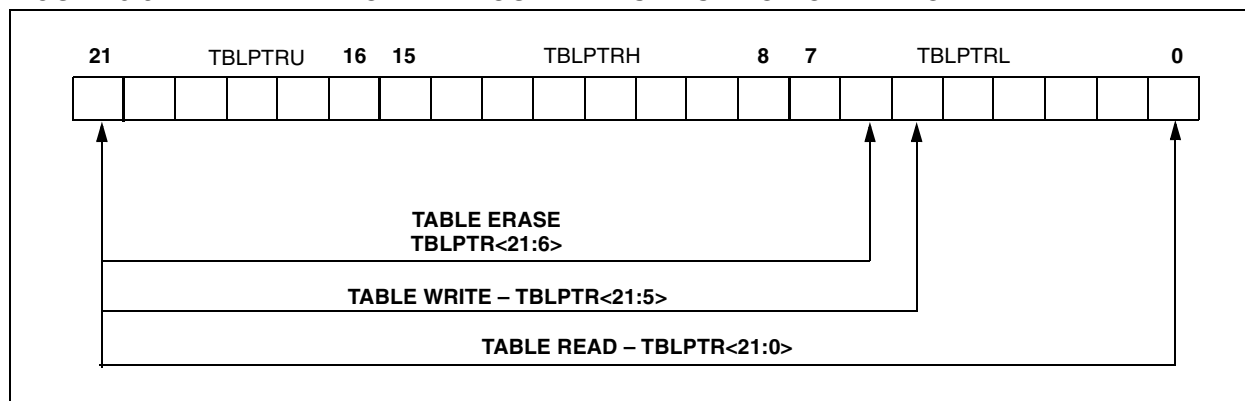
FIGURE 6-3: TABLE POINTER BOUNDARIES BASED ON OPERATION

#### 4. Module: Figure 6-3: Table Pointer Boundaries Based on Operation

Figure 6-3 has been replaced with the following figure:
